# **GARDEN GROVE SANITARY DISTRICT**

## **SEWER SYSTEM MANAGEMENT PLAN**

AKM Consulting Engineers  
553 Wald, Irvine, California 92618

**AUGUST 2016**

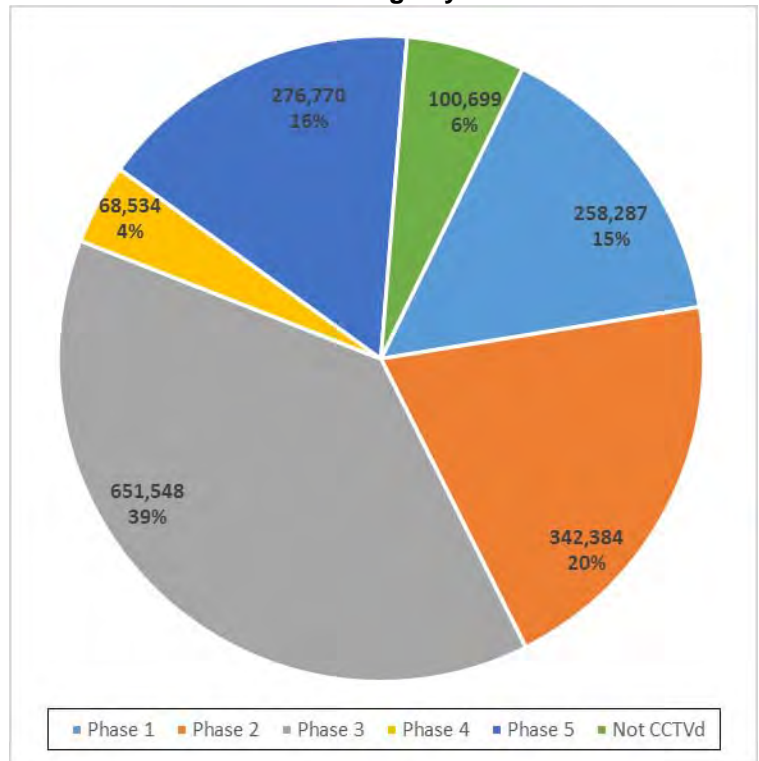
**Figure 5-3  
CCTV Footage by Phase**

The CCTV inspections and condition assessment were performed in five phases by the District staff, Performance Pipeline Technologies, and Empire Pipe. The inspection took place between November 2003 and October 2012. A summary of the CCTV inspection by phase is illustrated on Figure 5-3 and Figure 5-4. A summary of the CCTV inspections is included in Appendix D-3.

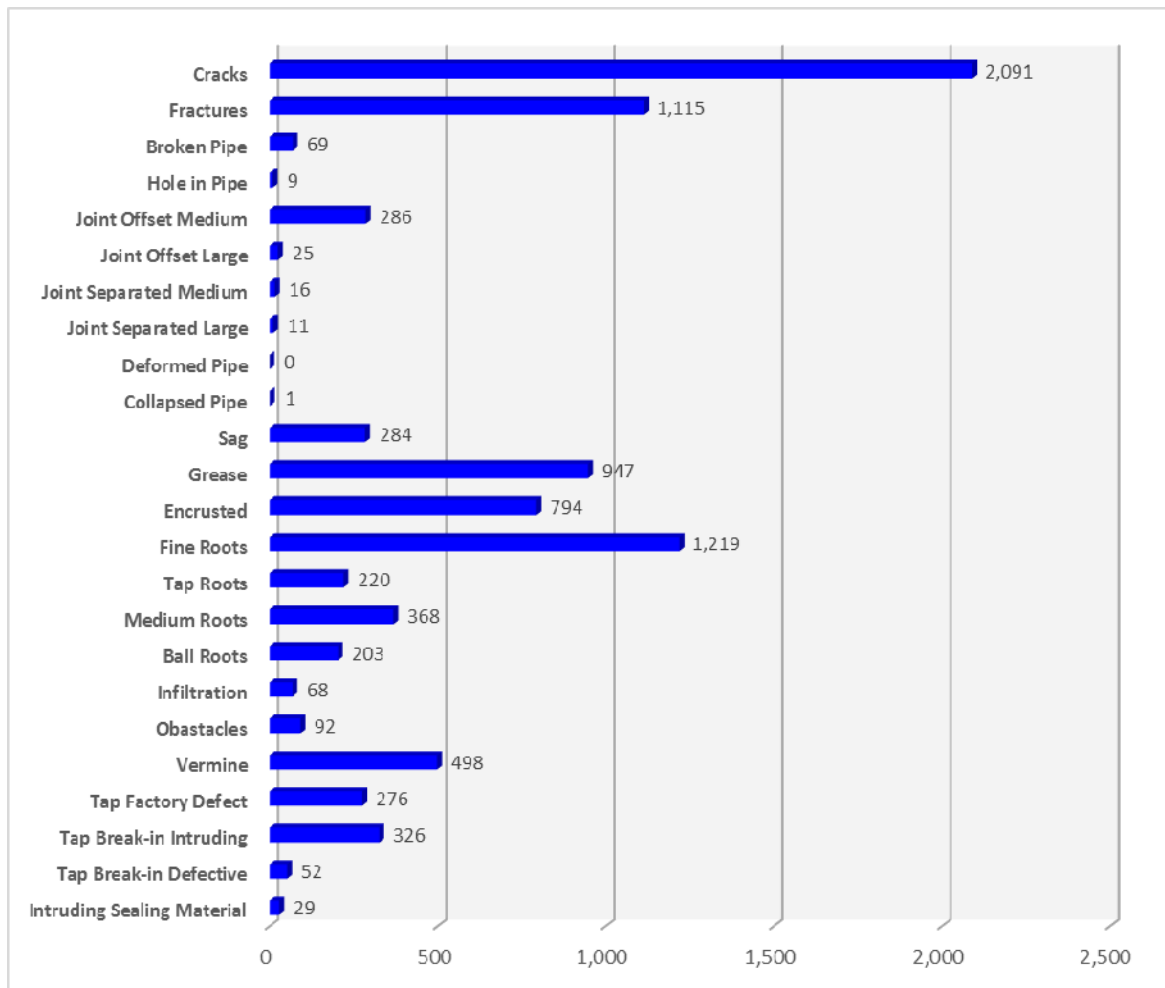
**Figure 5-5  
Sewer Reaches with Identified Deficiencies**

Figure 5-5 shows the number of reaches where an identified deficiency was found at least once within the reach. It provides a general sense of the magnitude of the problems that were found in the portion of the District's collection system that was CCTV inspected. The problems identified most were cracks (2,091 reaches, 30% of Total), fine roots (1,291 reaches, 18% of total), and fractures (1,115 reaches, 15% of total).

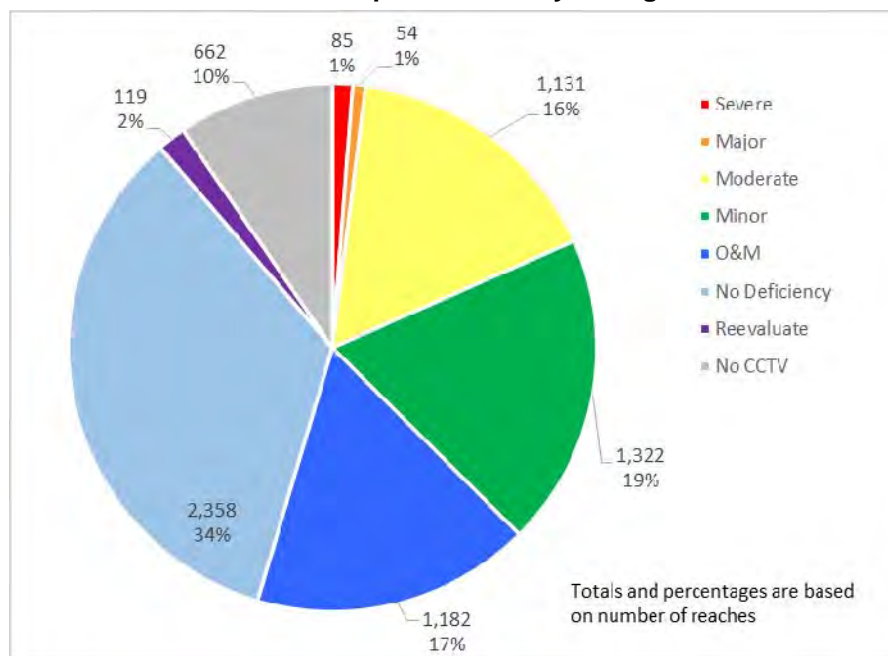
**Figure 5-6  
CCTV Inspection Priority Ratings**

Figure 5-6 illustrates the distribution of the comprehensive sewer priorities for the District's gravity sewer system.

Appendix D-3 lists the CCTV locations by initial replacement/rehabilitation priorities, from most to least severe, based on the structural condition of the pipes. Pipes that have been abandoned since its inspection are included for record keeping purposes. Appendix D-4 shows the CCTV locations color coded by rehabilitation/replacement priority.
